Produced For City of San Diego  
Dec 6, 2024

# FEASIBILITY STUDY

## Spindrift Drive Beach Access Walkway Alternatives Evaluation

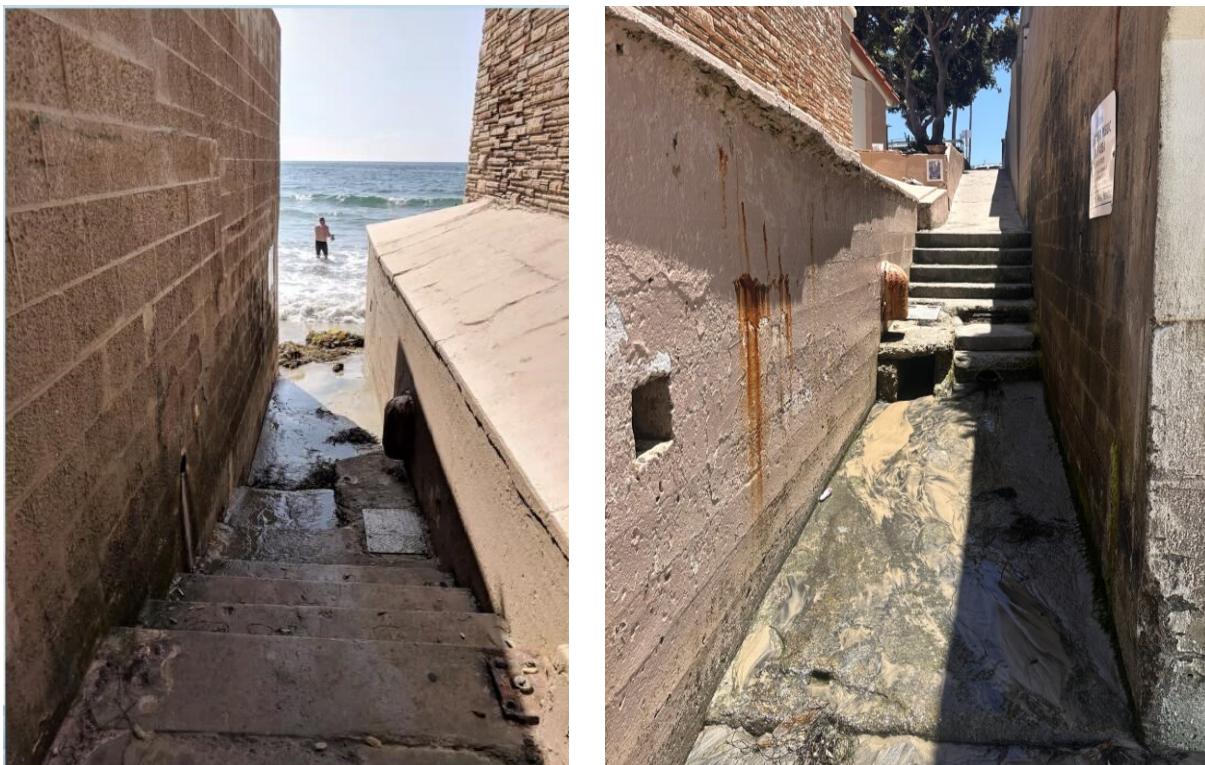
FIGURE 1: PICTURES OF THE EXISTING SPINDRIFT DRIVE BEACH ACCESS WALKWAY

The original walkway construction date is not known; however, a 1937 plat of survey depicts the walkway as a public lane with a flight of stairs leading down to the beach. Available as-built drawings of improvements made to the lower walkway stairs and storm drain outlet are dated from 1961. The existing structure is a 4' wide walkway and staircase, approximately 150' in length, with a vertical elevation drop of roughly 17'. It passes between the retaining walls of adjacent private properties, connecting Spindrift Drive to the beach. In addition, the access serves as an easement for an 18" storm drain pipe which runs underneath the walkway from street level to the beach. Over the years, the structure has faced deterioration due to exposure to the marine environment as well as stormwater runoff. Pictures of the existing walkway are provided in Figure 1.

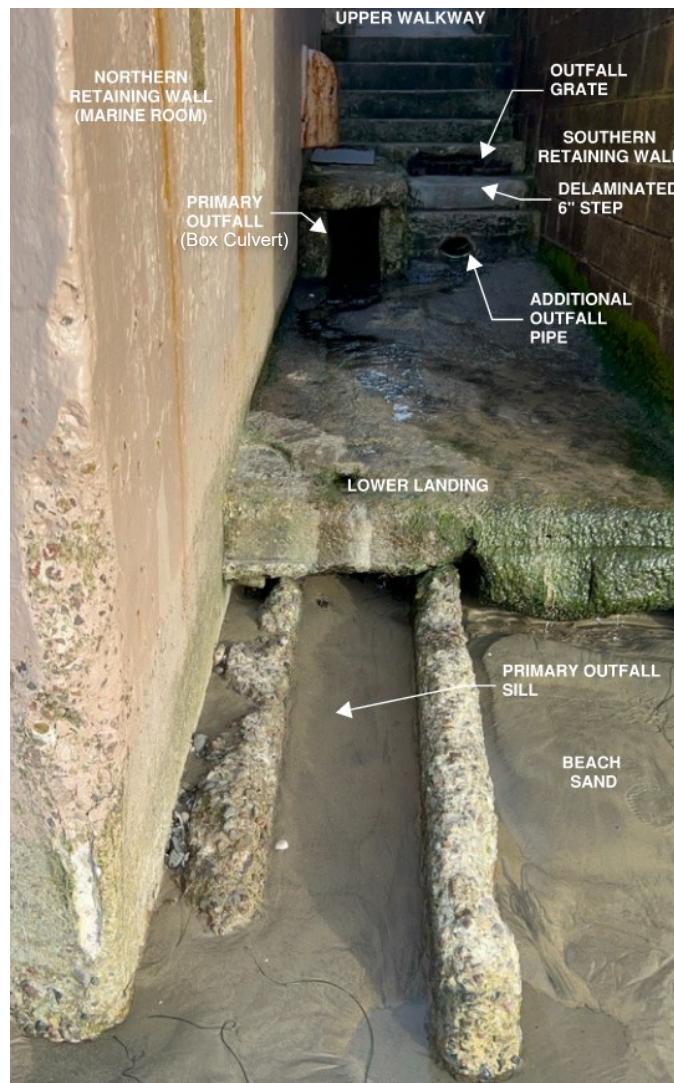
FIGURE 2: EXISTING WALKWAY PHOTO WITH KEY FEATURES IDENTIFIED

- **Upper Ramp:** The 115' ramp is in fair condition, showing no signs of delamination or significant defects, only normal pedestrian wear.
- **Staircase:** The concrete steps vary in condition with the lower steps in particularly poor condition, showing excessive deterioration due to their regular exposure to the marine environment along with pedestrian traffic. Full delamination of the 6<sup>th</sup> stair was noted, with the recommendation that it be demolished and replaced.

- **Lower Landing:** The 18' beach level landing is in fair condition but shows signs of significant wear along its length due to exposure to the marine environment, pedestrian traffic, and runoff from the storm drain outlets. Although not present during the investigation, scour issues at the end of the landing have been documented by the community.

- **Retaining Walls:** The adjacent retaining walls, although not owned by the City of San Diego, were inspected for overall assessment purposes. The walls are constructed of concrete masonry blocks and show some signs of corrosion spalling, but overall, they are in fair condition with no immediate repair needs.

- **Storm Drain Outfalls (External):** There are four storm drain openings of concern. The primary storm drain box culvert, located adjacent to the bottom stairs, is in poor condition, with significant erosion observed around the outlet. The storm drain outfall under the 7<sup>th</sup> step is in fair condition, while the storm drain grate embedded in the 5<sup>th</sup> step is severely corroded and in poor condition. While the primary outfall sill appears to be functional, it is severely eroded and its hydraulic capacity is greatly reduced by sand infill.

- **Storm Drain (Internal):** The existing 18" RCP was found to be in fair condition, with several fractures noted throughout the pipe length. Two previously unknown laterals, a 10" PVC pipe approximately 95' from the street level catch basin and a 6" PVC pipe approximately 104' from the upper catch basin, were identified taping into the storm drain line from the north. Sand infiltration obstructing 30-50% of the storm drain was noted beginning approximately 102' from the street level catch basin extending to the bottom outfall.

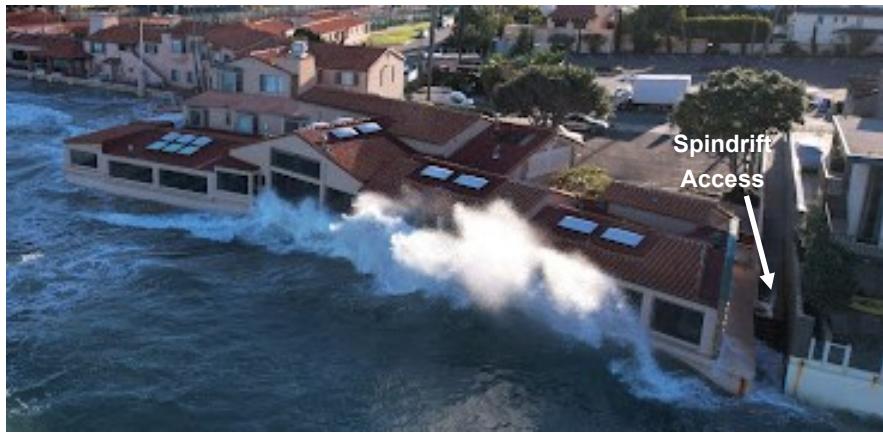
FIGURE 4: WAVE IMPACT DURING HIGH WATER LEVELS AT SPINDRIFT ACCESS

The site is subject to a variety of wave conditions, including long-period swell waves from the Pacific Ocean and local wind-generated waves. The proximity of La Jolla Point offers some protection, but broken waves, particularly from large northwesterly swell, can still reach the walkway, particularly during higher tide levels (Figure 4). The design must account for these wave forces, ensuring that the structure can withstand the most extreme wave conditions anticipated.

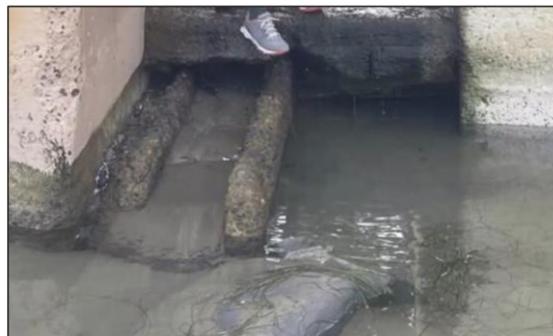
**FIGURE 5: EXAMPLE OF SEASONAL SCOUR AT EXISTING WALKWAY BOTTOM LANDING**

The shoreline near the Spindrift Access is currently experiencing a slow rate of erosion, which is expected to continue and potentially accelerate with SLR. Localized scours have also been seasonally observed at the toe of the existing walkway beach landing as illustrated in Figure 5. Scour could undermine the structural integrity of the stairs and cause a large drop-off from the bottom landing to the sandy beach. The design should accommodate for a minimum upper beach sand level of +1 to +2' NGVD (based on historical survey data per Appendix D Section 5) to the extent possible through control measures or anchoring into solid foundational material. A future beach level eroded to the underlying formation layer should be considered as a worst-case scenario with SLR.

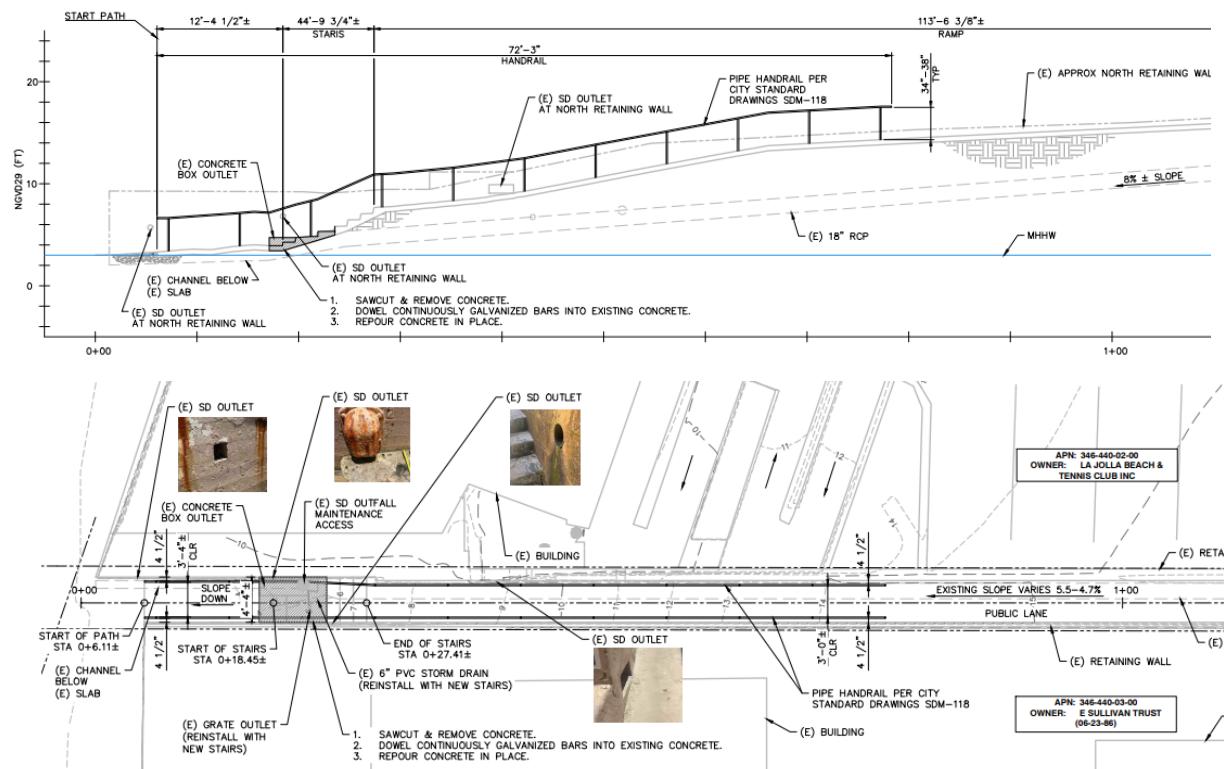
FIGURE 6: ALTERNATIVE 1 DESIGN

Alternative 1 proposes replacing structurally compromised components of the existing walkway, including the bottom three steps, storm drain grate, and box culvert, as shown in Figure 6 and Appendix A. The in-kind repairs will enhance structural integrity and extend the service life of the walkway; however, this alternative does not address future degradation of other sections of the walkway that are currently in fair condition and may not remain functional for the desired design life.

In addition, post-mounted handrails will be installed on the bottom landing, stairs, and sections of the upper walkway that exceed a 1:12 (8.33%) ramp slope. While the handrails improve accessibility, the effective width of the walkway would be correspondingly reduced, and many ADA deficiencies would remain unaddressed. Replaced stairs would be made compliant with ADA 1:48 (2%) slope requirements, but their dimensions and non-uniformity would remain in violation of code. Signage to the nearest ADA compliant beach access could be posted with visual striping added to stairs.

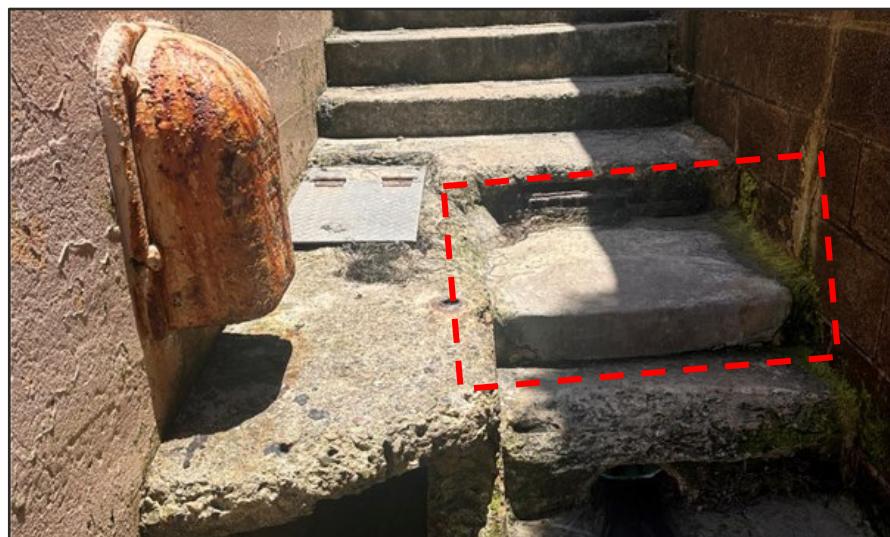
*Photo 2: Delamination of Step 6*

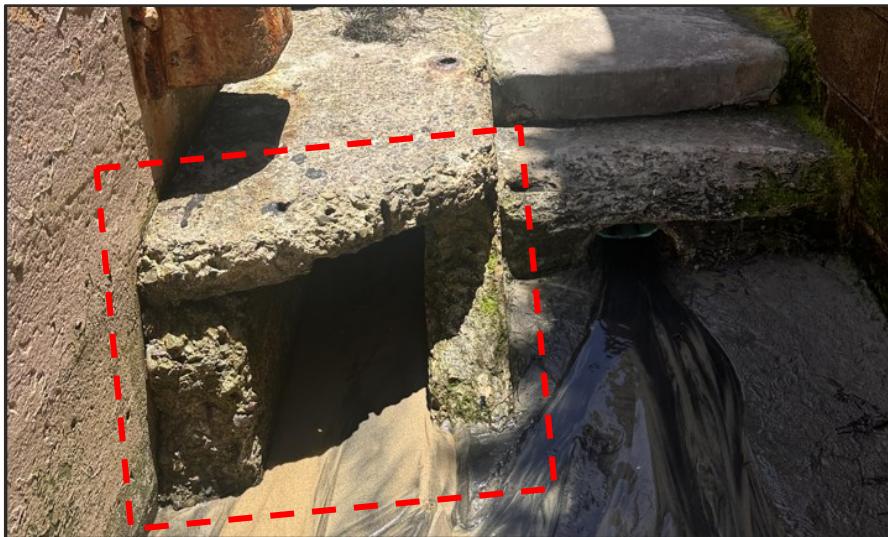
The exposed storm drain outfall components connected to the walkway were visually inspected. The primary outfall, shown in **Error! Reference source not found.** 7, is in poor condition with erosion along the outlet. The storm drain outfall underneath the 7<sup>th</sup> step, shown by Photo 8, is in fair condition with normal wear. The storm drain grate embedded in the 5<sup>th</sup> step is in poor condition and is severely corroded as shown in Photo 9. As part of the overall accessibility compliance feasibility study, a separate video inspection was conducted to investigate the internal integrity of the storm drain line running underneath the walkway.

*Photo 7: Box Culvert*

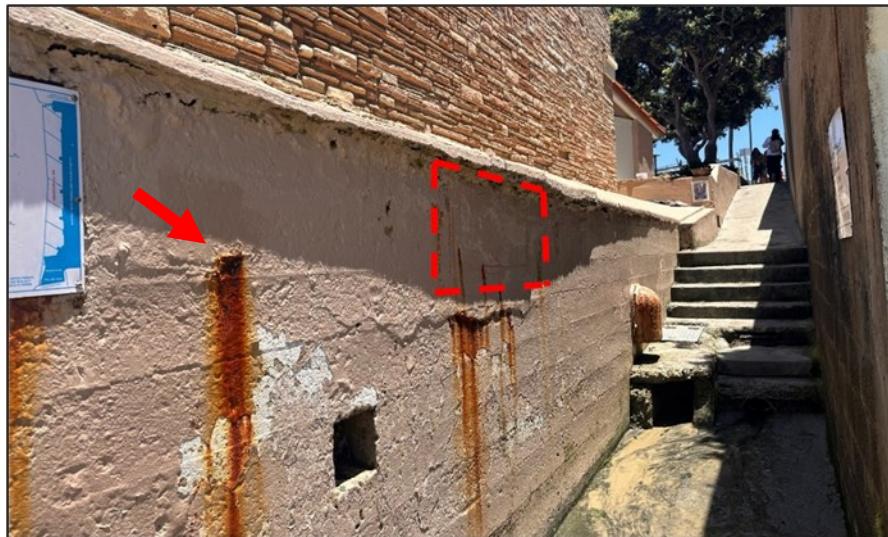
The adjacent retaining walls are constructed of concrete masonry blocks and are privately owned. The retaining walls were sounded, and two closed corrosion spalls (CCS) were located. One CCS was located on the northeast wall and is 30" long x 20" wide and is shown in Photo 10. The second CCS was located along the front wall of the northeast retaining wall and is 32" long x 32" wide and is shown in Photo 11. A retaining wall drainage outlet was in fair condition and shows no defects as shown in Photo 10.

Photo 10: Closed Corrosion Spalls along the Northeast Retaining Wall

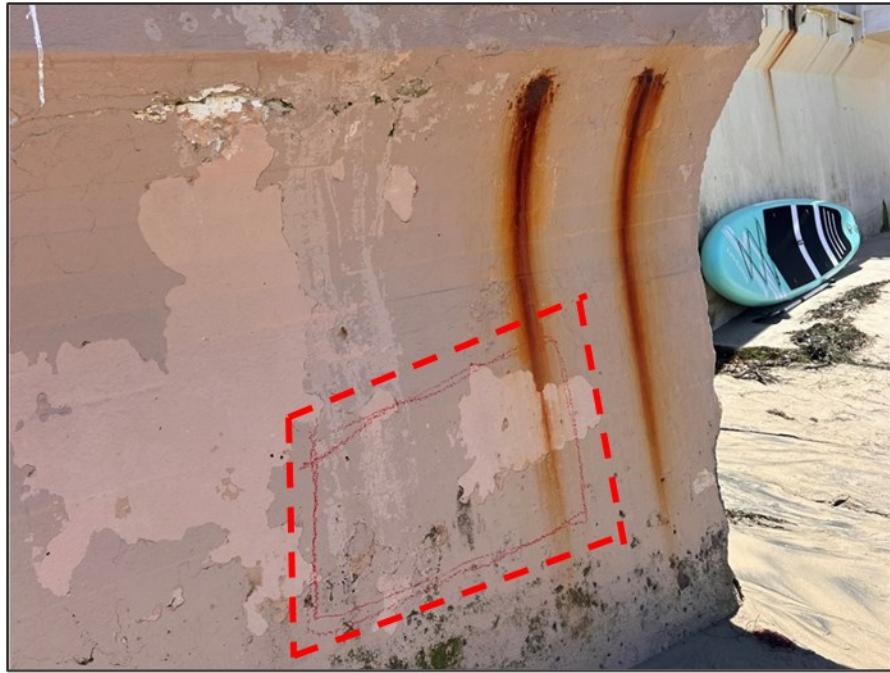
Photo 11: Closed Corrosion Spalls along the Front Face of the Northeast Retaining Wall

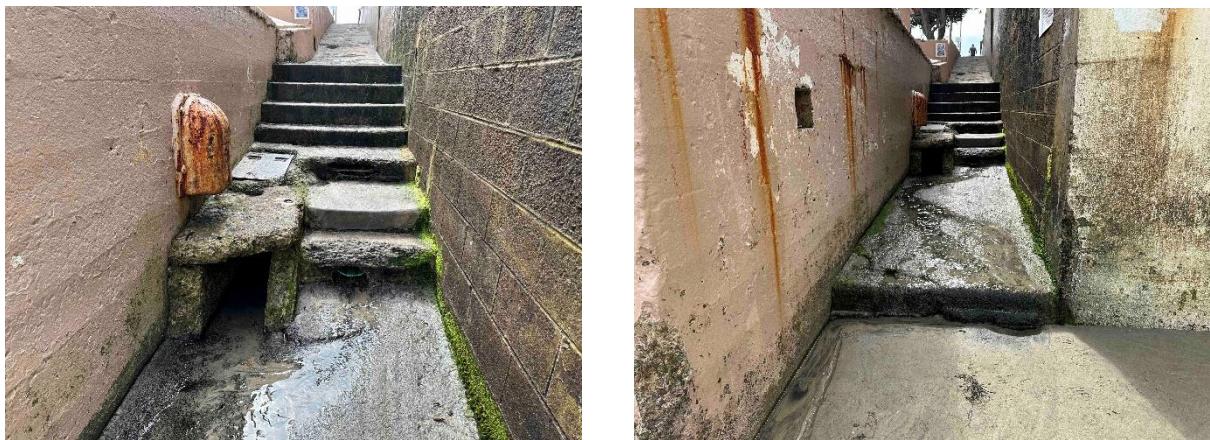
Figure 2 Existing Conditions at Stairs

The site is located at La Jolla Shores. The Spindrift Stairway is made up of seven (7) risers. The parcel of land a drainage easement to the City of San Diego and is 6-feet wide by approximately 140-feet long and with private property located on either side. 122' of 18" R.C.P. is located under the stairs with outlet structure at the base of the stairs and connects to a Type B-2 curb inlet at Spindrift Drive. The elevation at Spindrift Drive is 17.77 with an elevation of 4± at outlet structure resulting in a total elevation change of approximately 13.75 feet. The last riser provides a landing approximately 3' in width due to an existing outlet structure. (Figure 2)

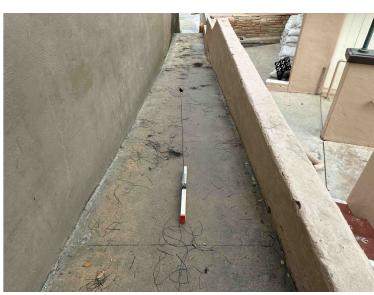
1.3	<p><b><u>Area of Noncompliance</u></b></p> <p><b>Stairs - Top Landing - Slope</b> Running slope at landing and treads exceeds 2% maximum. Excessive slopes range from 5.2% to 7.0% and has an uneven surface.</p> <p><b><u>Recommended Remediation</u></b> The walking surface of treads and landings of a stairway shall not be sloped steeper than one unit vertical in 48 units horizontal (2-percent slope) in any direction. Stair treads shall comply with Section 11B-302. Changes in level, slopes exceeding 1:48, and detectable warnings shall not be permitted.</p>	<p><b>2010 ADAS</b> 504.4 N</p> <p><b>2022 CBC</b> 1011.71 11B-504.4 N</p> <p><b>Measurement:</b> 7.0 % grade</p>

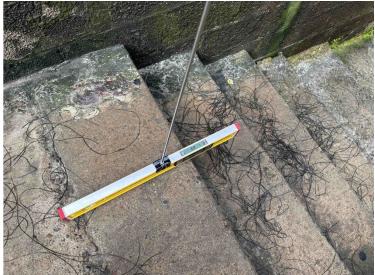
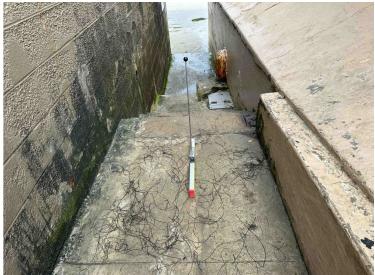
1.4	<p><b><u>Area of Noncompliance</u></b></p> <p><b>Stairs - Treads - Slope</b> Running slope at treads exceeds 2% maximum. Running slopes range from 2.3% to 15.9%.</p> <p><b><u>Recommended Remediation</u></b> Stair treads shall comply with Section 11B-302. Changes in level, slopes exceeding 1:48, and detectable warnings shall not be permitted.</p>	<p><b>2010 ADAS</b> 504.4 N</p> <p><b>2022 CBC</b> 11B-504.4 N</p> <p><b>Measurement:</b> 15.9 % grade</p>

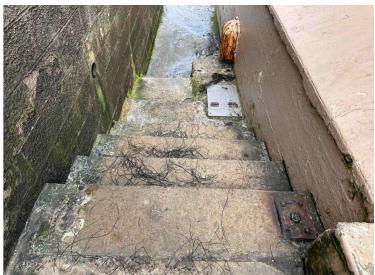
1.5	<p><b><u>Area of Noncompliance</u></b></p> <p><b>Stairs - Bottom Landing - Slope</b> Running slope at landing and treads exceeds 2% maximum. Excessive slope at bottom landing is 10.4% and has an uneven surface.</p> <p><b><u>Recommended Remediation</u></b> The walking surface of treads and landings of a stairway shall not be sloped steeper than one unit vertical in 48 units horizontal (2-percent slope) in any direction. Stair treads shall comply with Section 11B-302. Changes in level, slopes exceeding 1:48, and detectable warnings shall not be permitted.</p>	<p><b>2010 ADAS</b> 504.4 N</p> <p><b>2022 CBC</b> 1011.71 11B-504.4 N</p> <p><b>Measurement:</b> 10.4 % grade</p>

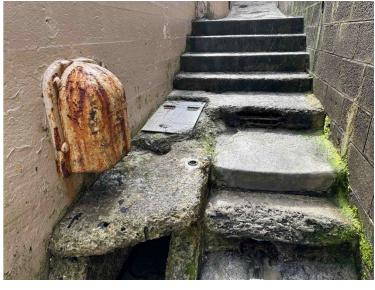
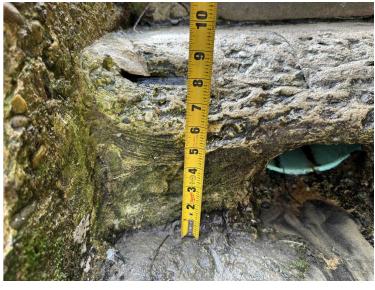
1.8	<p><b><u>Area of Noncompliance</u></b></p> <p><b>Stairs - Treads - Uniformity</b> Depths on risers vary in depth. 9-1/2" to 26-1/2"</p> <p><b><u>Recommended Remediation</u></b> Replace steps to provide uniform tread depths on the flight of stairs. Stair treads and risers shall be of uniform size and shape. The tolerance between the largest and smallest riser height or between the largest and smallest tread depth shall not exceed 3/8 inch in any flight of stairs.</p>	<p><b>2010 ADAS</b> 504.3 N</p> <p><b>2022 CBC</b> 1011.5.4 11B-504.3 N</p> <p><b>Measurement:</b> 7 count</p>

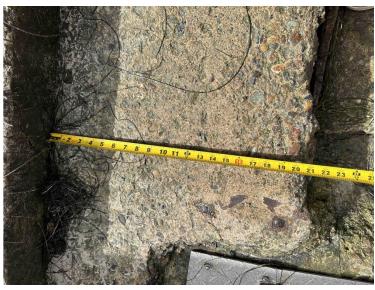
1.9	<p><b><u>Area of Noncompliance</u></b></p> <p><b>Stairs - Landing - Slope</b> Running slope at landing and treads exceeds 2% maximum. Excessive slopes is 6.8% with bottom landing being sand.</p> <p><b><u>Recommended Remediation</u></b> The walking surface of treads and landings of a stairway shall not be sloped steeper than one unit vertical in 48 units horizontal (2-percent slope) in any direction. Stair treads shall comply with Section 11B-302. Changes in level, slopes exceeding 1:48, and detectable warnings shall not be permitted.</p>	<p><b>2010 ADAS</b> 504.4 N</p> <p><b>2022 CBC</b> 1011.71 11B-504.4 N</p> <p><b>Measurement:</b> 6.8 % grade</p>

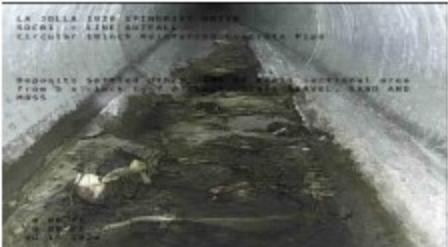
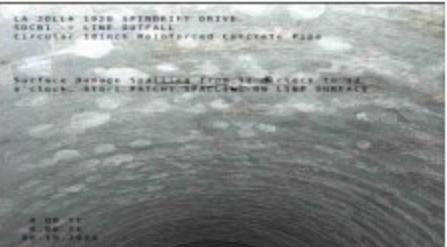
<p><b>6_19_2024 8_38_47</b>          AM_c935e4ba-b6d6-4bf2-bb19-20621609d127_20240619_08          4327_146.jpg, 00:01:09, 0.00ft          Deposits Settled Other, 10% of cross sectional area from 5          o'clock to 7 o'clock, Start / GRAVEL, SAND AND MOSS</p>

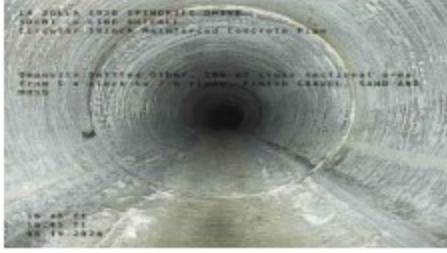
6\_19\_2024 8\_38\_47  
AM\_3caa1bbd-c059-41bb-84b3-c3f17a6236ae\_20240619\_08  
4718\_082.jpg, 00:04:07, 16.45ft  
Deposits Settled Other, 10% of cross sectional area from 5 o'clock to 7 o'clock, Finish / GRAVEL, SAND AND MOSS

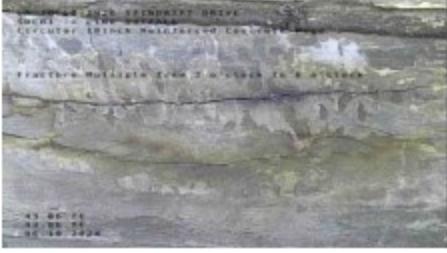
6\_19\_2024 8\_38\_47  
AM\_0f726960-950d-4a27-bdab-65484b535c8c\_20240619\_08  
5206\_898.jpg, 00:08:43, 43.86ft  
Fracture Multiple from 2 o'clock to 6 o'clock

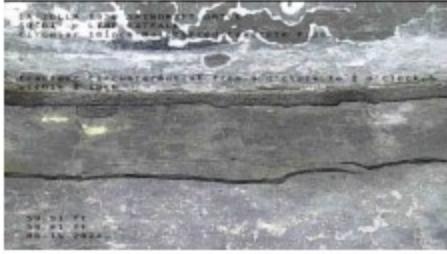
6\_19\_2024 8\_38\_47  
AM\_79d5b197-3ead-4be2-a2c1-094cd389c15d\_20240619\_08  
5526\_624.jpg, 00:11:39, 59.91ft  
Fracture Circumferential from 9 o'clock to 2 o'clock, within 8 inch

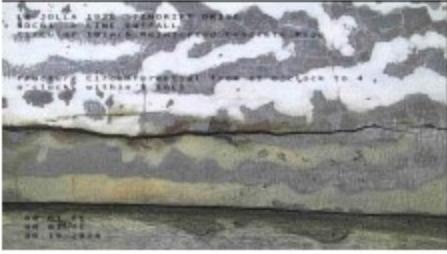
6\_19\_2024 8\_38\_47  
AM\_24de2c71-ad68-427b-a8a7-a4956208227b\_20240619\_08  
5707\_843.jpg, 00:13:06, 68.01ft  
Fracture Circumferential from 11 o'clock to 4 o'clock, within 8 inch

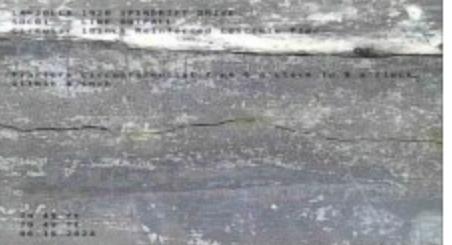
LA JOLLA 1920 SPINDRIFT DRIVE  
SOCR1 - LINE OUTFALL  
SECTION 10inch REINFORCED CONCRETE PIPE  
Fracture Circumferential from 6 o'clock to 9 o'clock, within 8 inch  
6.19.2024 8:38:47  
AM\_ebbea3c3-e284-47a1-8a5f-781c465b12c0\_20240619\_090220\_074.jpg, 00:17:20, 79.49ft

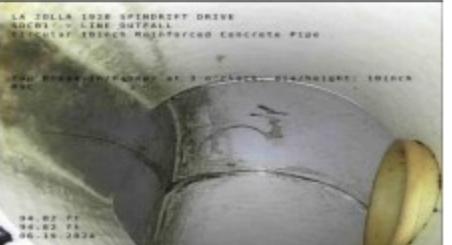
LA JOLLA 1920 SPINDRIFT DRIVE  
SOCR1 - LINE OUTFALL  
SECTION 10inch REINFORCED CONCRETE PIPE  
Tap Break-in/Hammer at 3 o'clock, dia/height: 10inch / PVC  
6.19.2024 8:38:47  
AM\_786d60c6-9c16-4fe3-851d-6b8abd75ba58\_20240619\_090711\_433.jpg, 00:21:24, 94.82ft

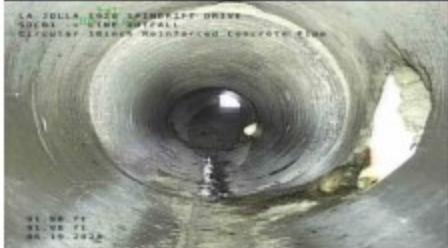
<p>6_19_2024 8_38_47 AM_e3a77e7c-027d-4fd1-9f41-c945a03d9907_20240619_090735_259.jpg, 00:21:24, 94.82ft Tap Break-in/Hammer at 3 o'clock, dia/height: 10inch / PVC</p>				
<p>6_19_2024 8_38_47 AM_cae6832-be4d-403f-affc-bb08a0190e83_20240619_090952_269.jpg, 00:23:22, 95.53ft Fracture Circumferential from 4 o'clock to 8 o'clock, within 8 inch</p>

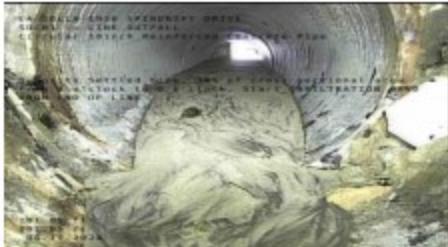
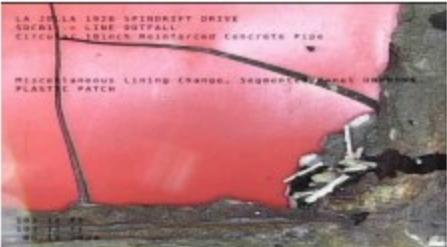
<p>6_19_2024 8_38_47 AM_b7adda81-4e80-4bfe-80fe-d08caa6d08c1_20240619_091118_439.jpg, 00:23:52, 101.05ft Deposits Settled Fine, 30% of cross sectional area from 4 o'clock to 8 o'clock, Start / INFILTRATION SAND FROM END OF LINE</p>				
<p>6_19_2024 8_38_47 AM_962a7287-cb1-4510-8ccb-3d07d8e623b8_20240619_091459_815.jpg, 00:26:03, 103.12ft Miscellaneous Lining Change, Segmented Panel / UNKNOWN PLASTIC PATCH</p>

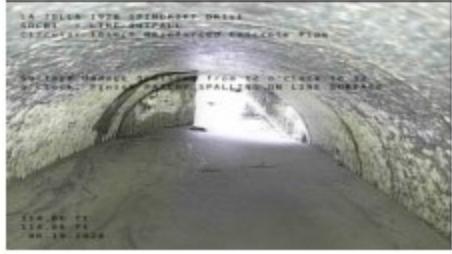
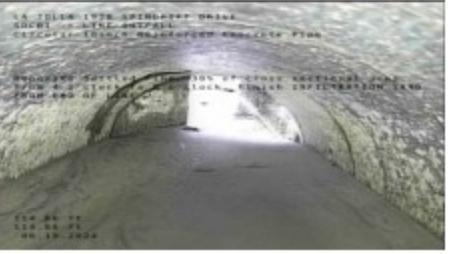
6_19_2024 8_38_47 AM_8c770fa7-19ed-4bc6-ad08-7ff79a8851d6_20240619_091617_299.jpg, 00:27:16, 114.85ft Surface Damage Spalling from 12 o'clock to 12 o'clock, Finish / PATCHY SPALLING ON LINE SURFACE		6_19_2024 8_38_47 AM_bdee165d-46f5-4218-ac34-ac563d5f81eb_20240619_091630_270.jpg, 00:27:21, 114.86ft Deposits Settled Fine, 30% of cross sectional area from 4 o'clock to 8 o'clock, Finish / INFILTRATION SAND FROM END OF LINE
