Produced For City of San Diego  
Dec 6, 2024

# FEASIBILITY STUDY

## Spindrift Drive Beach Access Walkway Alternatives Evaluation

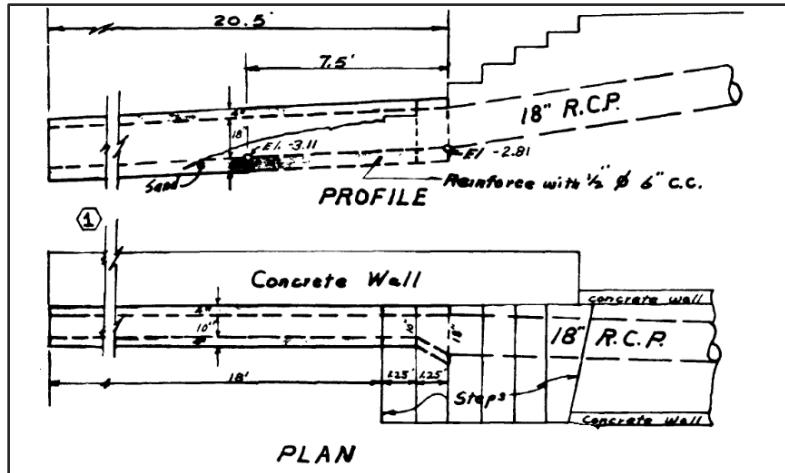
**FIGURE 3: 1961 LOWER WALKWAY STORM DRAIN IMPROVEMENT AS-BUILT DRAWINGS**

- **Upper Ramp:** The 115' ramp is in fair condition, showing no signs of delamination or significant defects, only normal pedestrian wear.
- **Staircase:** The concrete steps vary in condition with the lower steps in particularly poor condition, showing excessive deterioration due to their regular exposure to the marine environment along with pedestrian traffic. Full delamination of the 6<sup>th</sup> stair was noted, with the recommendation that it be demolished and replaced.

- **Lower Landing:** The 18' beach level landing is in fair condition but shows signs of significant wear along its length due to exposure to the marine environment, pedestrian traffic, and runoff from the storm drain outlets. Although not present during the investigation, scour issues at the end of the landing have been documented by the community.

- **Storm Drain Outfalls (External):** There are four storm drain openings of concern. The primary storm drain box culvert, located adjacent to the bottom stairs, is in poor condition, with significant erosion observed around the outlet. The storm drain outfall under the 7<sup>th</sup> step is in fair condition, while the storm drain grate embedded in the 5<sup>th</sup> step is severely corroded and in poor condition. While the primary outfall sill appears to be functional, it is severely eroded and its hydraulic capacity is greatly reduced by sand infill.

- **Storm Drain (Internal):** The existing 18" RCP was found to be in fair condition, with several fractures noted throughout the pipe length. Two previously unknown laterals, a 10" PVC pipe approximately 95' from the street level catch basin and a 6" PVC pipe approximately 104' from the upper catch basin, were identified taping into the storm drain line from the north. Sand infiltration obstructing 30-50% of the storm drain was noted beginning approximately 102' from the street level catch basin extending to the bottom outfall.

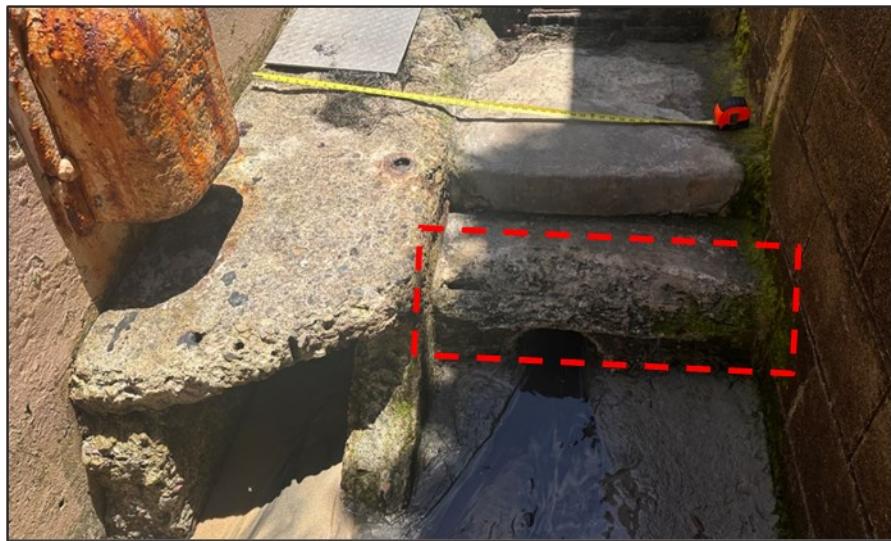
Photo 3: Erosion of Step 7

The concrete steps were sounded and the 6<sup>th</sup> step showed signs of full delamination. The delaminated section is 30" wide x 28" long x 6" deep and is shown by **Error! Reference source not found.** There are signs of excessive wear on the 7<sup>th</sup> step, as shown in Photo 3, likely due to regular pedestrian traffic and exposure to the harsh marine environment. During high tides, surf regularly impacts the walkway, scouring out a hole under the 8<sup>th</sup> step and washing sand onto the steps as is shown by Photo 4. Additional considerations for scour are assessed in a separate coastal hazard investigation study.

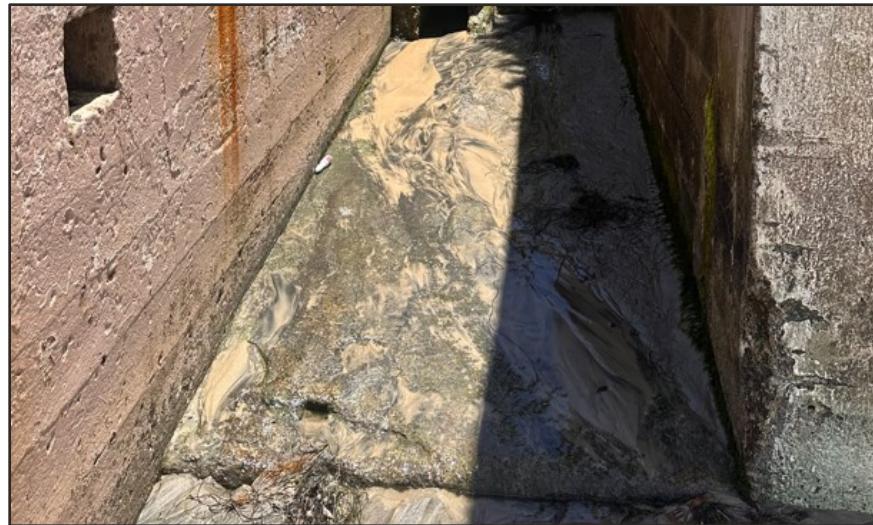
*Photo 5: Typical Landing Erosion*

The 18' concrete landing section is in fair condition with no signs of delamination; however, it does exhibit signs of excessive wear as shown by Photo 5. This section is periodically submerged during times of high tide. Increased damage on the bottom landing is likely due to regular pedestrian traffic, exposure to the harsh marine environment, and runoff from the connected storm drain outlets. There is additional erosion located at the west end of the landing that is 24" wide x 18" long x 4" deep and is shown by Photo 6.

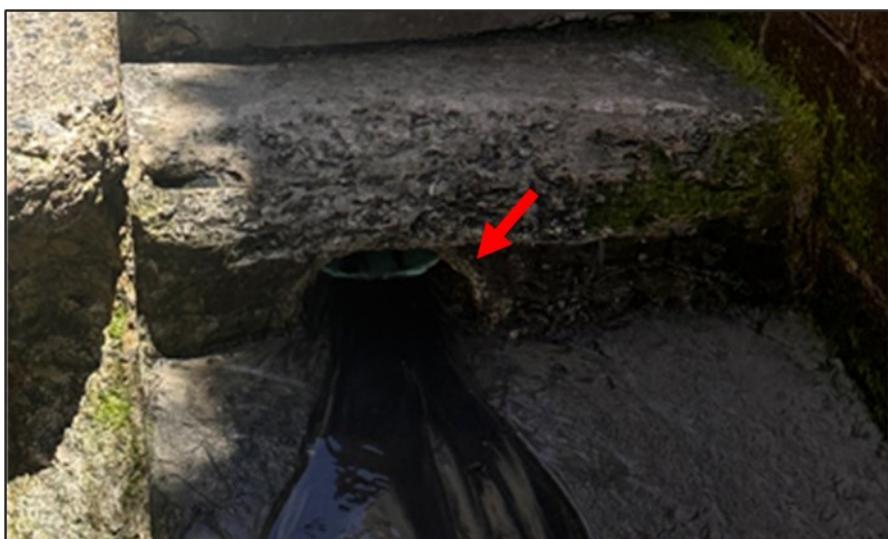
*Photo 8: Storm Drain Outfall*

The exposed storm drain outfall components connected to the walkway were visually inspected. The primary outfall, shown in **Error! Reference source not found.** 7, is in poor condition with erosion along the outlet. The storm drain outfall underneath the 7<sup>th</sup> step, shown by Photo 8, is in fair condition with normal wear. The storm drain grate embedded in the 5<sup>th</sup> step is in poor condition and is severely corroded as shown in Photo 9. As part of the overall accessibility compliance feasibility study, a separate video inspection was conducted to investigate the internal integrity of the storm drain line running underneath the walkway.

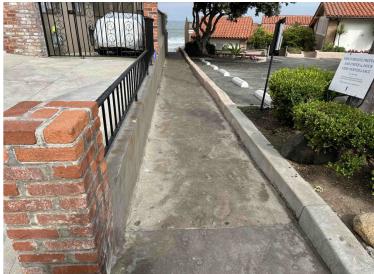
1.1	<p><b><u>Area of Noncompliance</u></b></p> <p><b>Accessible Route - Slopes - Cross Slope</b> The cross slope of accessible routes exceeds 1:48 (2.0 %). Cross slope of 3.0%.</p> <p><b><u>Recommended Remediation</u></b></p> <p>Remove and replace walk. Install walk that provides cross slopes at circulation route of 1:48 maximum.</p>	<p><b>2010 ADAS</b> 405.2 N</p> <p><b>2022 CBC</b> 11B-406.5.7 N</p>

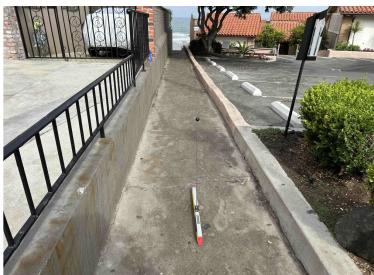
1.2	<p><b><u>Area of Noncompliance</u></b></p> <p><b>Accessible Route - Slopes - Running Slope</b> The slope in the direction of travel exceeds the allowable 5%. Excessive running slopes range from 5.2% to 19.4%.</p> <p><b><u>Recommended Remediation</u></b></p> <p>Accessible routes shall consist of one or more of the following components: walking surfaces with a running slope not steeper than 1:20, doorways, ramps, curb ramps excluding the flared sides, elevators, and platform lifts.</p>	<p><b>2010 ADAS</b> 402.2 N</p> <p><b>2022 CBC</b> 11B-402.2 N</p> <p><b>Measurement:</b> 19.4 % grade</p>

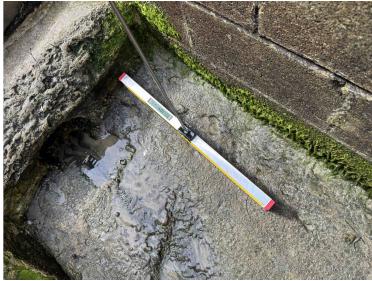
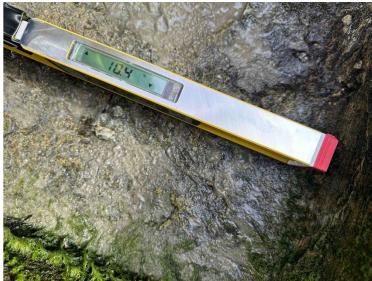
1.5	<p><b><u>Area of Noncompliance</u></b></p> <p><b>Stairs - Bottom Landing - Slope</b> Running slope at landing and treads exceeds 2% maximum. Excessive slope at bottom landing is 10.4% and has an uneven surface.</p> <p><b><u>Recommended Remediation</u></b> The walking surface of treads and landings of a stairway shall not be sloped steeper than one unit vertical in 48 units horizontal (2-percent slope) in any direction. Stair treads shall comply with Section 11B-302. Changes in level, slopes exceeding 1:48, and detectable warnings shall not be permitted.</p>	<p><b>2010 ADAS</b> 504.4 N</p> <p><b>2022 CBC</b> 1011.71 11B-504.4 N</p> <p><b>Measurement:</b> 10.4 % grade</p>

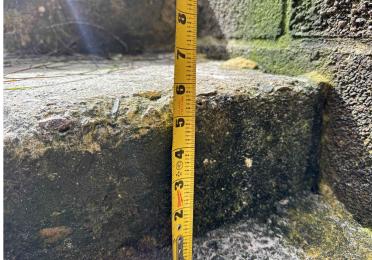
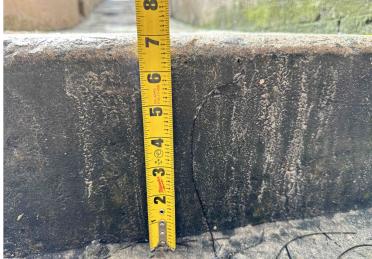
1.6	<p><b><u>Area of Noncompliance</u></b></p> <p><b>Stairs - Risers - Uniformity</b> All steps on a flight of stairs do not provide uniform riser heights and/or uniform tread depths. Heights range from 5-3/4" to 9-1/2".</p> <p><b><u>Recommended Remediation</u></b> Replace steps to provide uniform riser heights. The tolerance between the largest and smallest riser height or between the largest and smallest tread depth shall not exceed 3/8 inch in any flight of stairs.</p>	<p><b>2010 ADAS</b> 504.3 N</p> <p><b>2022 CBC</b> 11B-504.3 N</p> <p><b>Measurement:</b> 7 count</p>

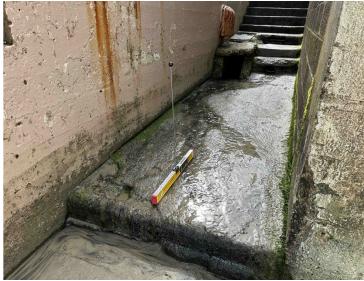
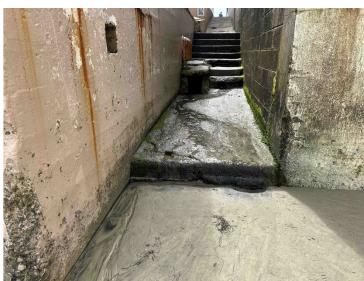
1.9	<p><b><u>Area of Noncompliance</u></b></p> <p><b>Stairs - Landing - Slope</b> Running slope at landing and treads exceeds 2% maximum. Excessive slopes is 6.8% with bottom landing being sand.</p> <p><b><u>Recommended Remediation</u></b> The walking surface of treads and landings of a stairway shall not be sloped steeper than one unit vertical in 48 units horizontal (2-percent slope) in any direction. Stair treads shall comply with Section 11B-302. Changes in level, slopes exceeding 1:48, and detectable warnings shall not be permitted.</p>	<p><b>2010 ADAS</b> 504.4 N</p> <p><b>2022 CBC</b> 1011.71 11B-504.4 N</p> <p><b>Measurement:</b> 6.8 % grade</p>

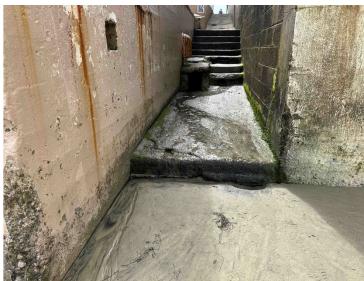
1.10	<p><b><u>Area of Noncompliance</u></b></p> <p><b>Accessible Route - Clear Width - General</b> Accessible route widths do not provide minimum 48-inches clear consistently at stairs due to drainage.</p> <p><b><u>Recommended Remediation</u></b> Replace walks to provide a clear width of 48 inches (1219 mm) minimum. When, because of right-of-way restrictions, natural barriers or other existing conditions, the enforcing agency determines that compliance with the 48-inch (1219 mm) clear sidewalk width would create an unreasonable hardship, the clear width may be reduced to 36 inches (914 mm).</p>	<p><b>2010 ADAS</b> 403.5.1 Y</p> <p><b>2022 CBC</b> 11B-403.5.1 (Ex 3-Exterior) N</p>

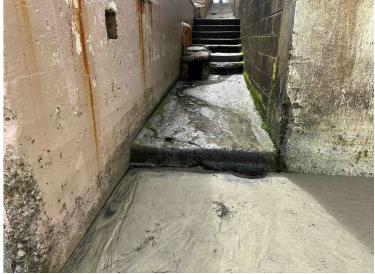
1.11	<p><b><u>Area of Noncompliance</u></b></p> <p><b>Stairs - Handrails - Both Sides</b> Handrails are not provided on both sides of the staircase.</p> <p><b><u>Recommended Remediation</u></b> Install missing handrails so they are provided on both sides of stairs and ramps.</p>	<p><b>2010 ADAS</b> 505.2 N</p> <p><b>2022 CBC</b> 11B-505.2 N</p> <p><b>Measurement:</b> 2 count</p>

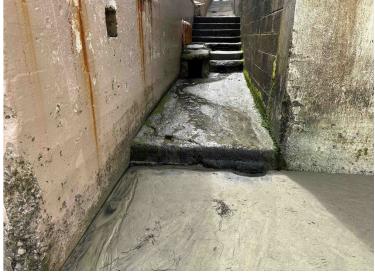
1.12	<p><b><u>Area of Noncompliance</u></b></p> <p><b>Stairs - Contrast Striping - Exterior Stair</b> A 2-inch minimum to 4-inch maximum clear visual contrast stripe is not provided on each step.</p> <p><b><u>Recommended Remediation</u></b> Provide clear visual contrast striping at the upper approach and all treads . The stripe shall be a minimum of 2 inches wide to a maximum of 4 inches wide. A painted stripe shall be acceptable. Grooves shall not be used to satisfy this requirement.</p>	<p><b>2010 ADAS</b> N/A N/A</p> <p><b>2022 CBC</b> 11B-504.4.1 N</p> <p><b>Measurement:</b> 8 count</p>

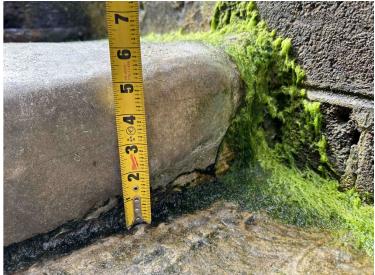
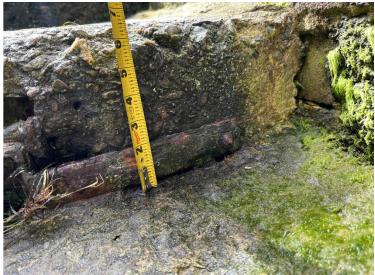
1.13	<p><b><u>Area of Noncompliance</u></b></p> <p><b>Stairs - Nosing - Radius</b> The curvature at the leading edge of the tread exceeds the maximum of <math>\frac{1}{2}</math> inch radius. Risers are not uniform in the nosing.</p> <p><b><u>Recommended Remediation</u></b> Adjust risers to provide a radius of curvature at the leading edge of the tread to <math>\frac{1}{2}</math> inch (12.7 mm) maximum.</p>	<p><b>2010 ADAS</b> 504.5 N</p> <p><b>2022 CBC</b> 11B-504.5 N</p> <p><b>Measurement:</b> 8 count</p>

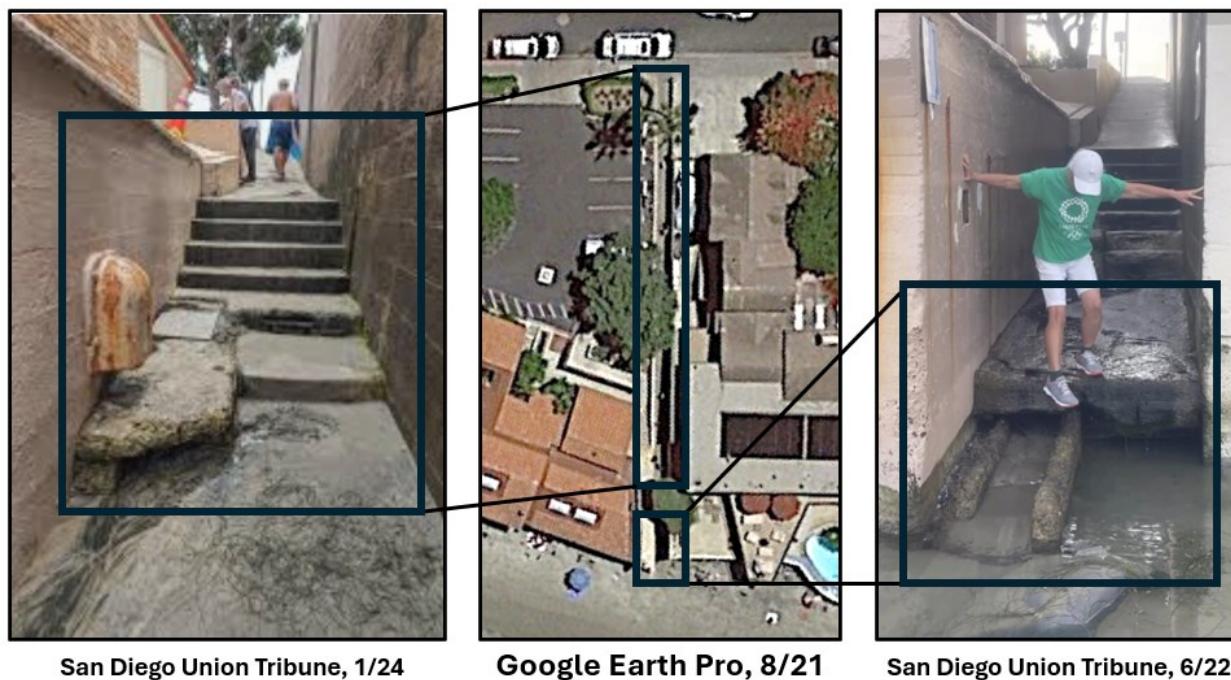
**FIGURE 3: CURRENT BEACH ACCESS WALKWAY CONDITION**

Figure 3 shows a Google Earth image of the walkway along with accompanying pictures taken at the site. This figure highlights two of the main features of the staircase: the upper staircase and walkway, with upper drainpipe (left) and the lower step and lower drainage onto the beach.

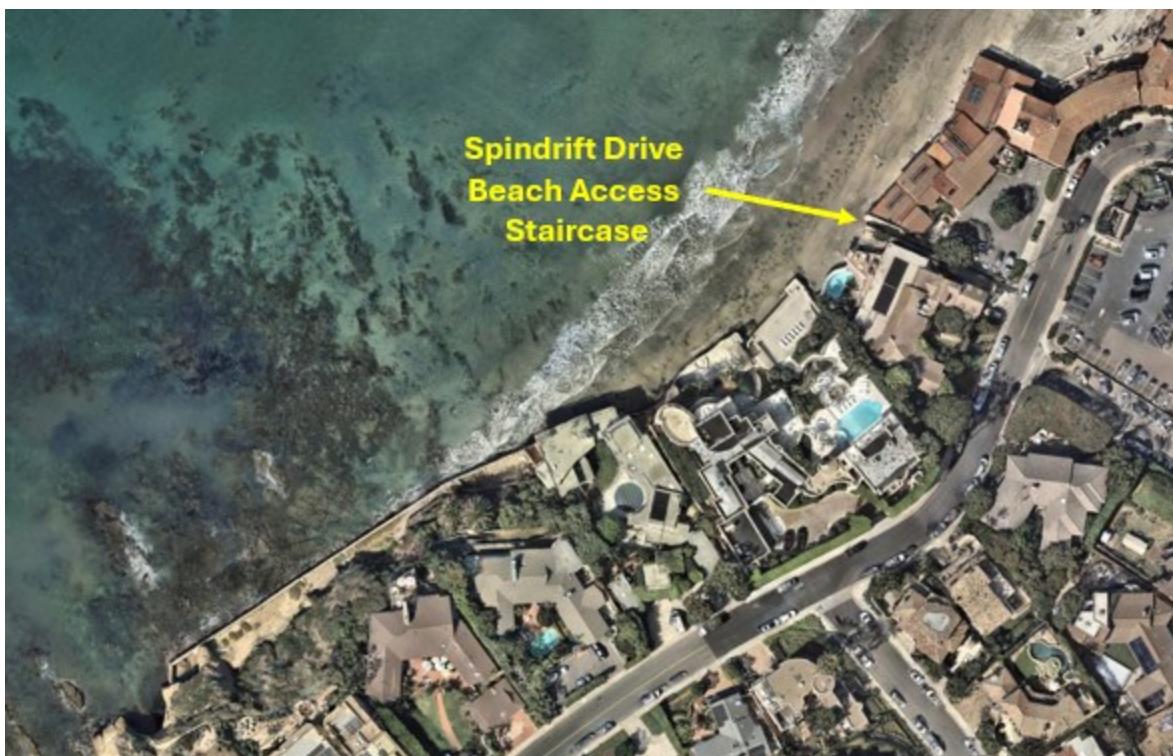
FIGURE 4: VERTICAL SEAWALLS ON EITHER SIDE OF SPINDRIFT ACCESSWAY

The private property at 1920 Spindrift Drive was constructed in 1955, also with retaining walls. These walls, however, terminate about 5' landward of the Marine Room seawall. Figure 4 illustrates the vertical seawalls along this reach of beach.
